SUBJECT: Site Inspection, Hecla Mining Company, Escalante Silver Mine,
M/021/004, Iron County, Utah

Date of Inspection: March 22, 2004
Time of Inspection: 2:00 p.m.
Conditions: Sunny, Humid
Participants: Doug Jensen, DOGM

Inspected the site to assess conditions of the 2002 reclamation of a waste pile at the site, and to check the tailings revegetation area for possible release. In a letter dated September 9, 2003, Hecla had requested the release of the portion of the bond covering the revegetation success of the tailings area.

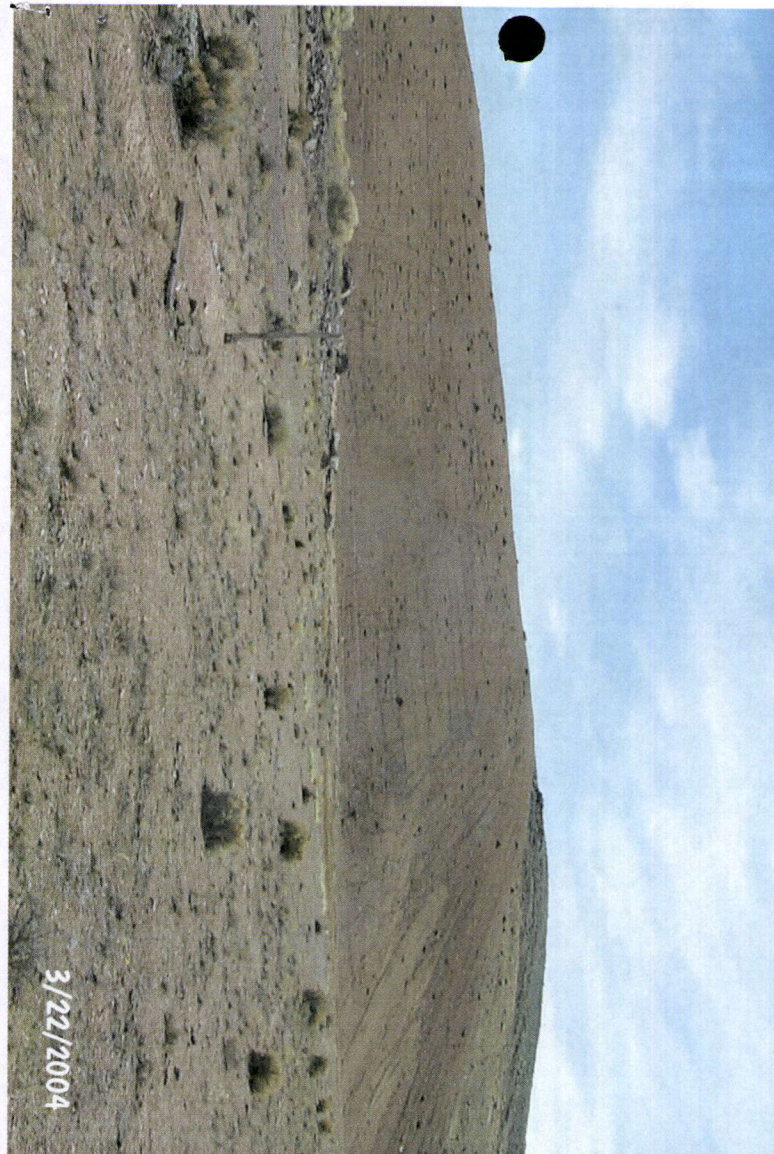
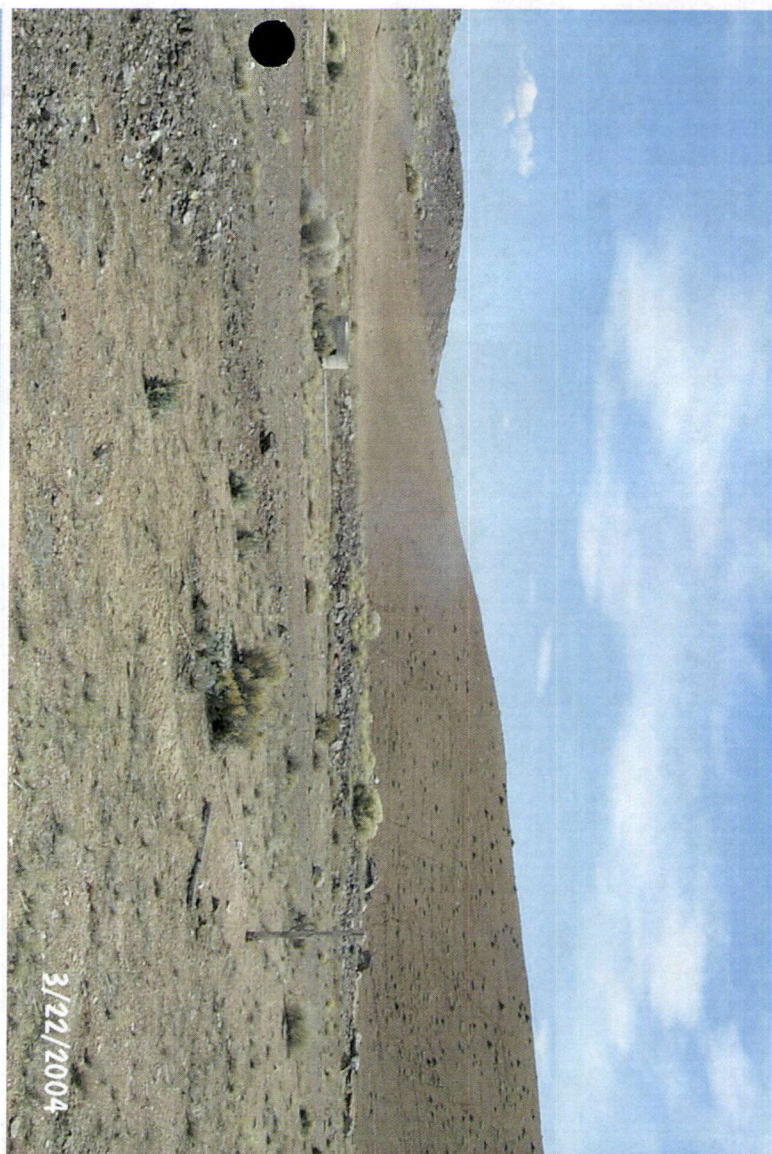
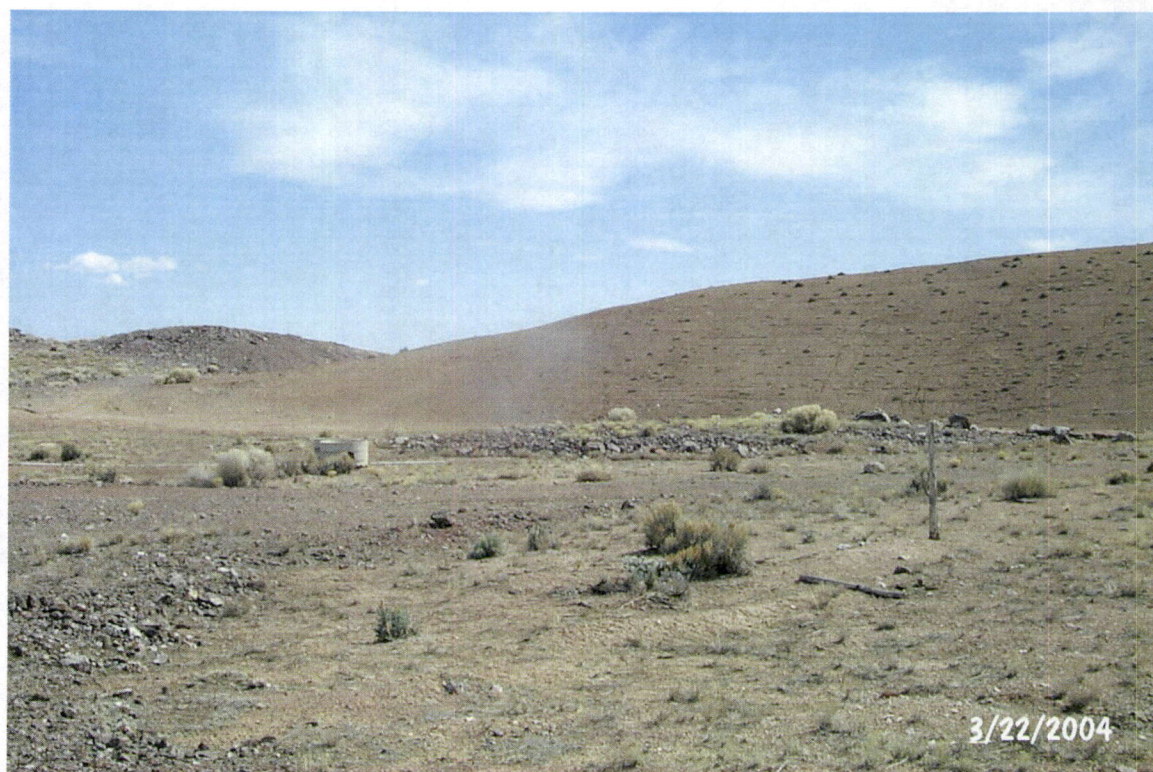
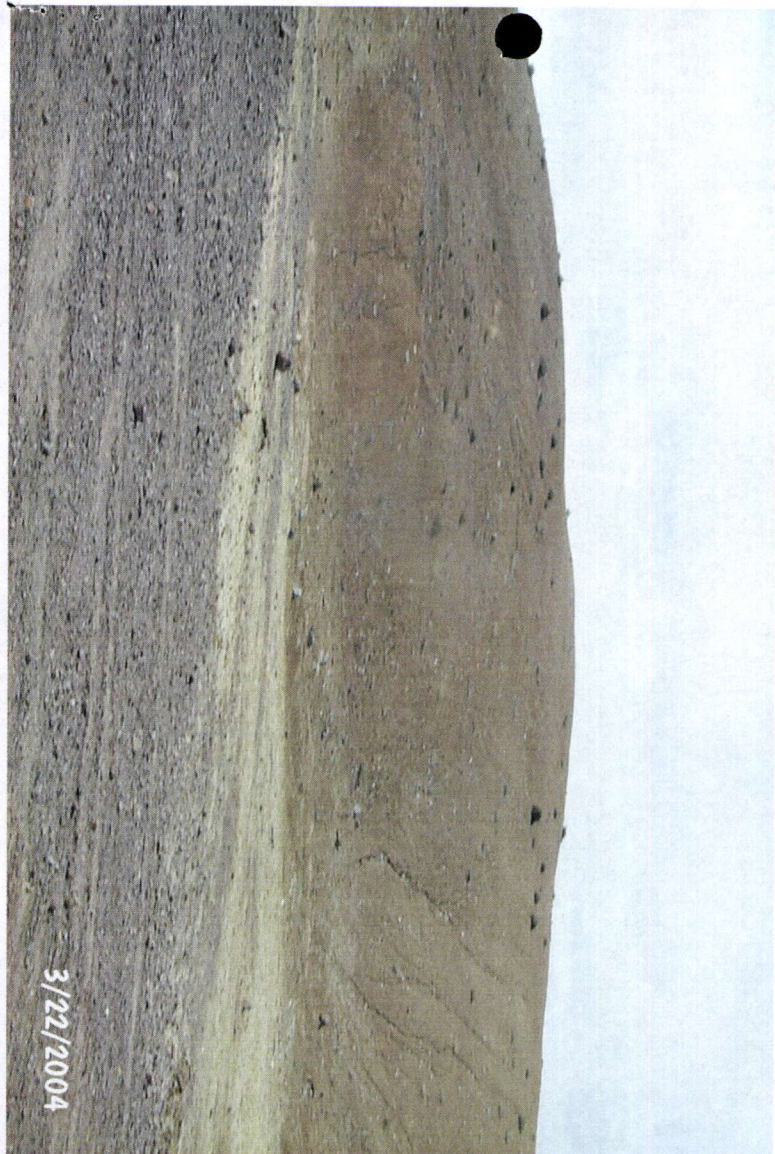
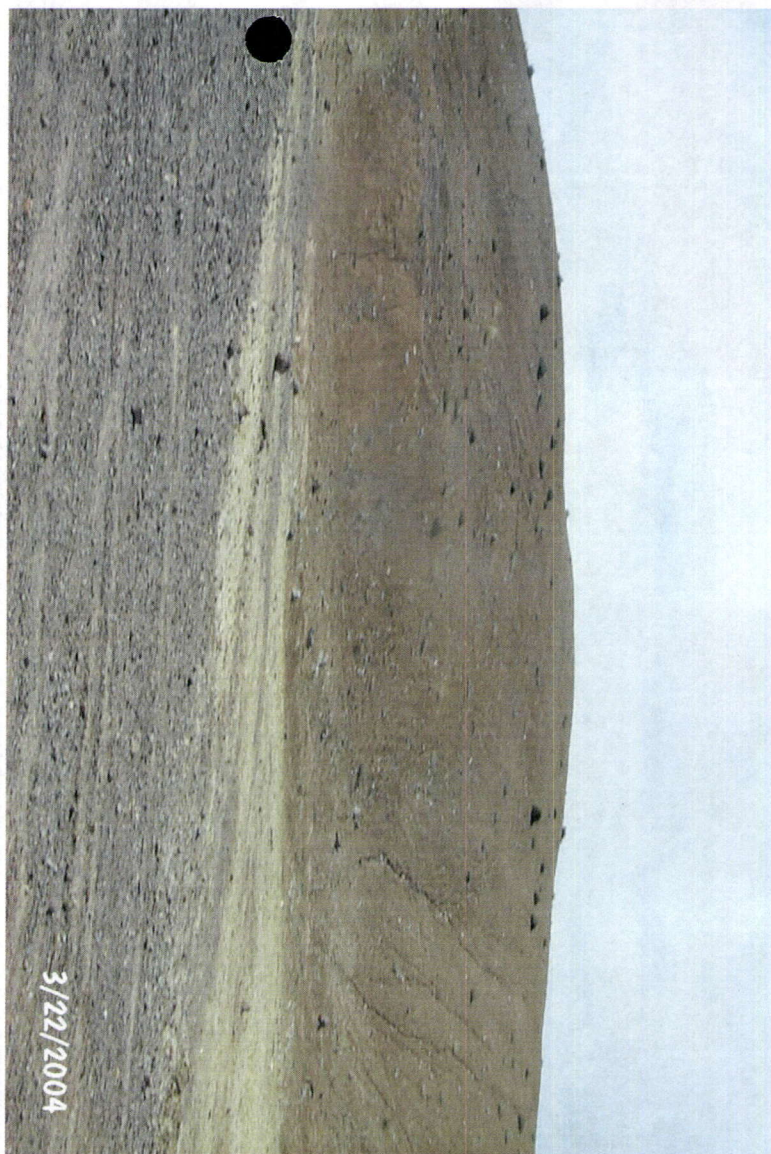
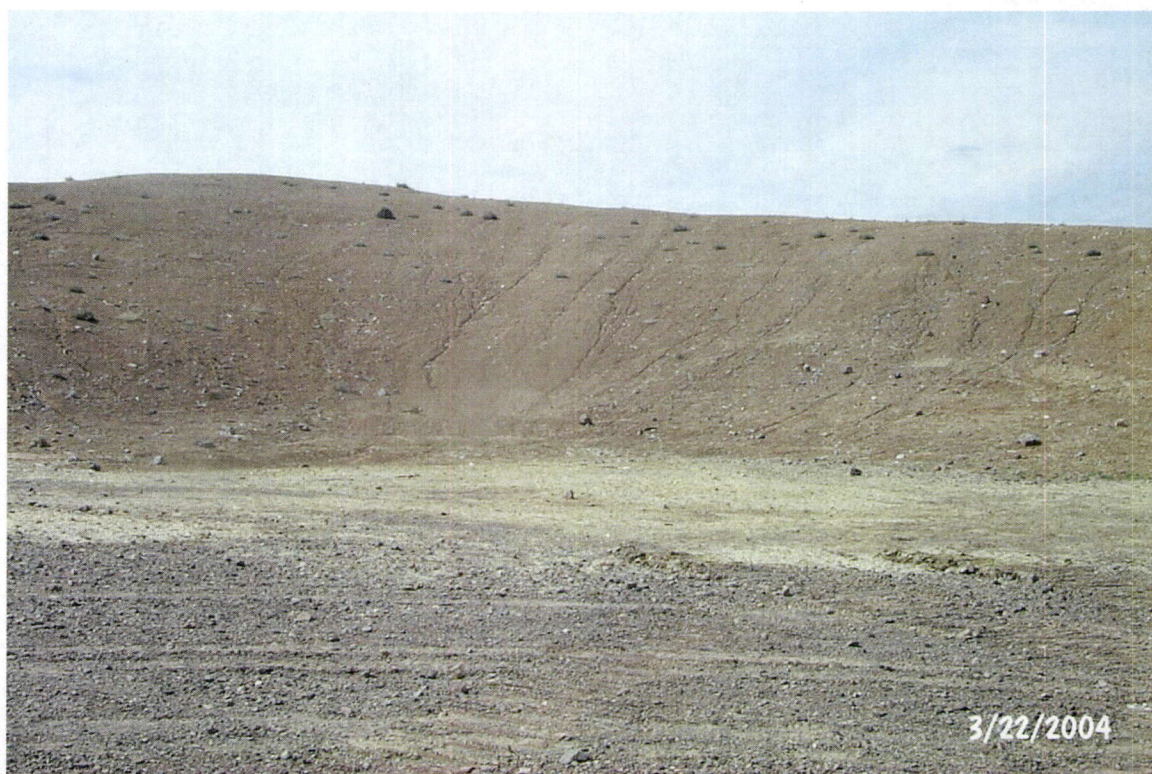
When the growth material was placed on the pile, the surface had been left smooth; no attempt had been made to roughen it. Because the surface was not ripped on contour as recommended, there are signs that some erosion is beginning to show on the pile. Also it appears that most of the manure that was placed on the pile had washed to the area at the base of the pile. Pictures of the waste pile were taken and are included in this report.

I walked the pile to check for signs of any plant growth. The only growth that I could see was several plants that appeared to be Russian thistle.

Because the weather had only just started to warm up at the site, I will check the site later in the summer to check on the results from the revegetation effort.

I will be visiting the site later with Ed Ginouves of the Cedar City BLM, when he checks the tailings area for noxious weeds (spotted-knapweed). Hopefully a decision can be made at that time as to whether the BLM will release this area. The Division's reluctance to release any part of the bond for this area is tied to BLM's insistence that the spotted-knapweed problem in this area be cleared up before they will agree to release the tailings area. Unless the BLM and the Division agree that this noxious weed problem has been eradicated, none of the bonding for this area will be released.
